Rockfall hazard

Rock mass characterization

Monitoring

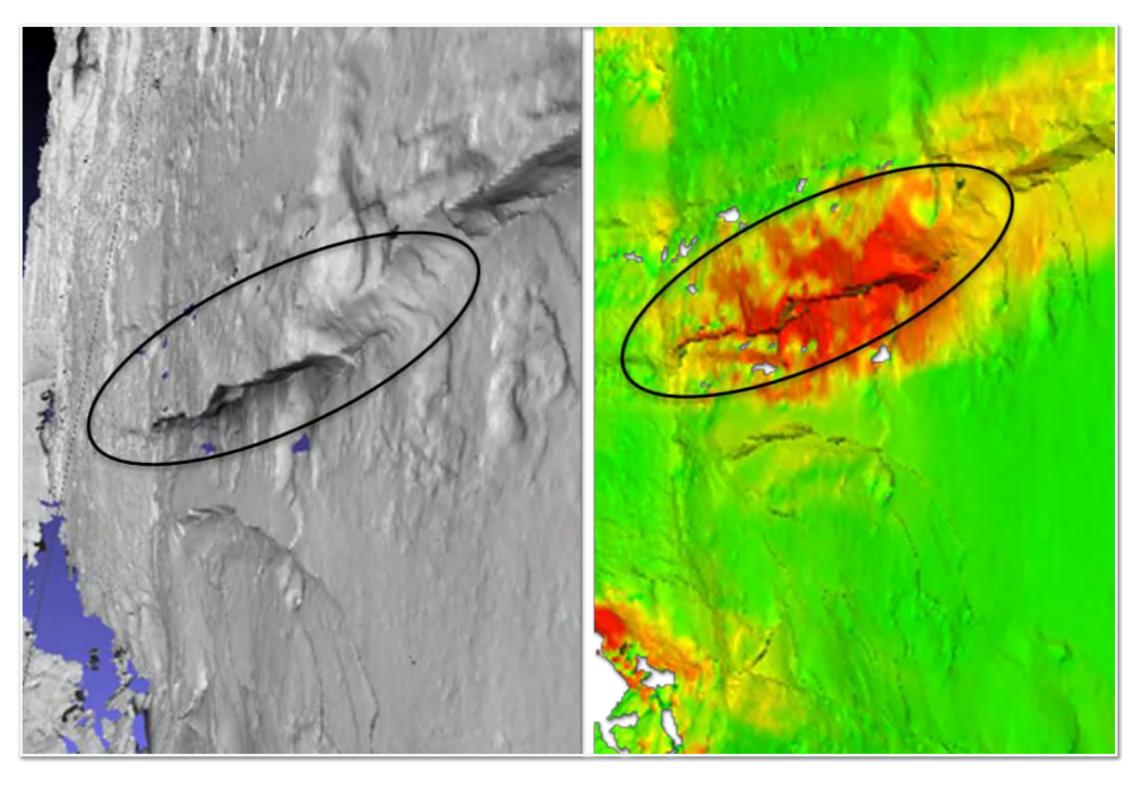
Rockfall prediction

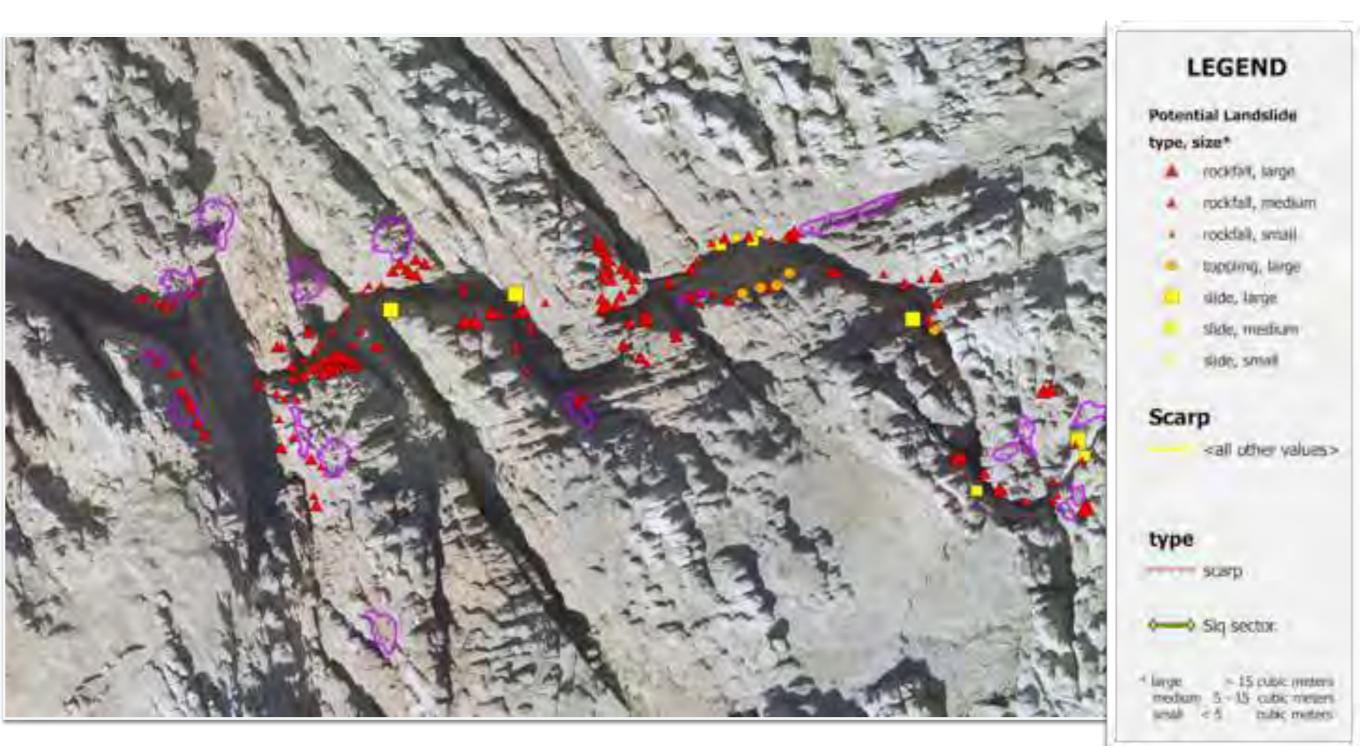
Hazard mapping

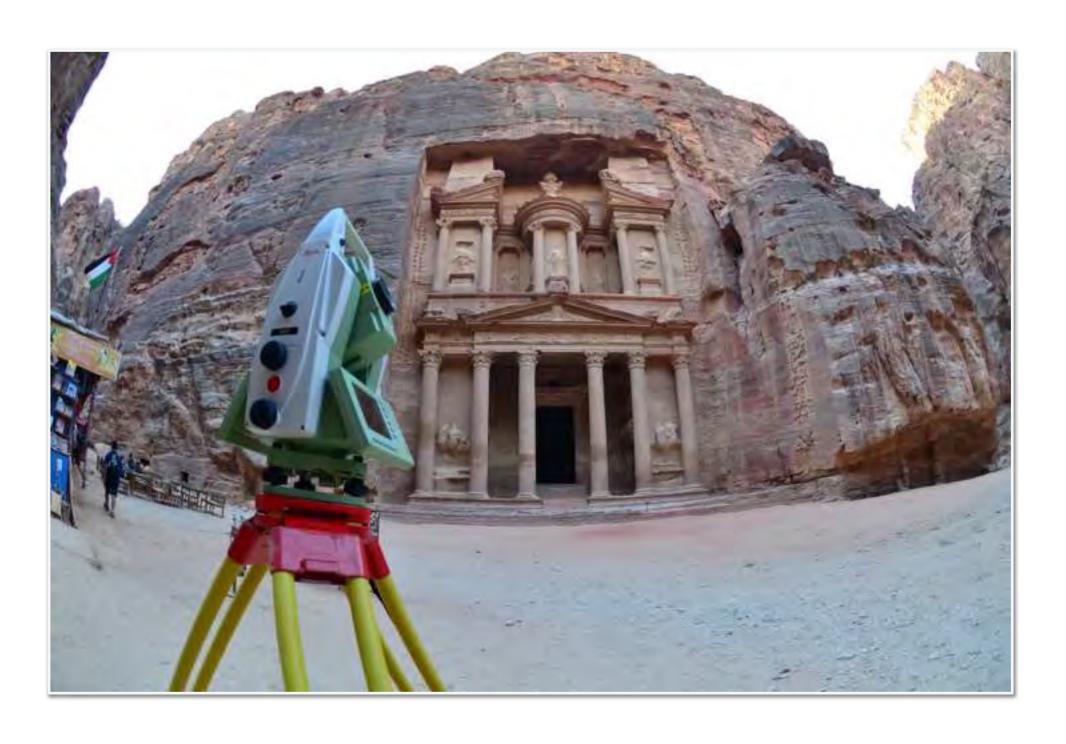
Robotized reflector-less total station

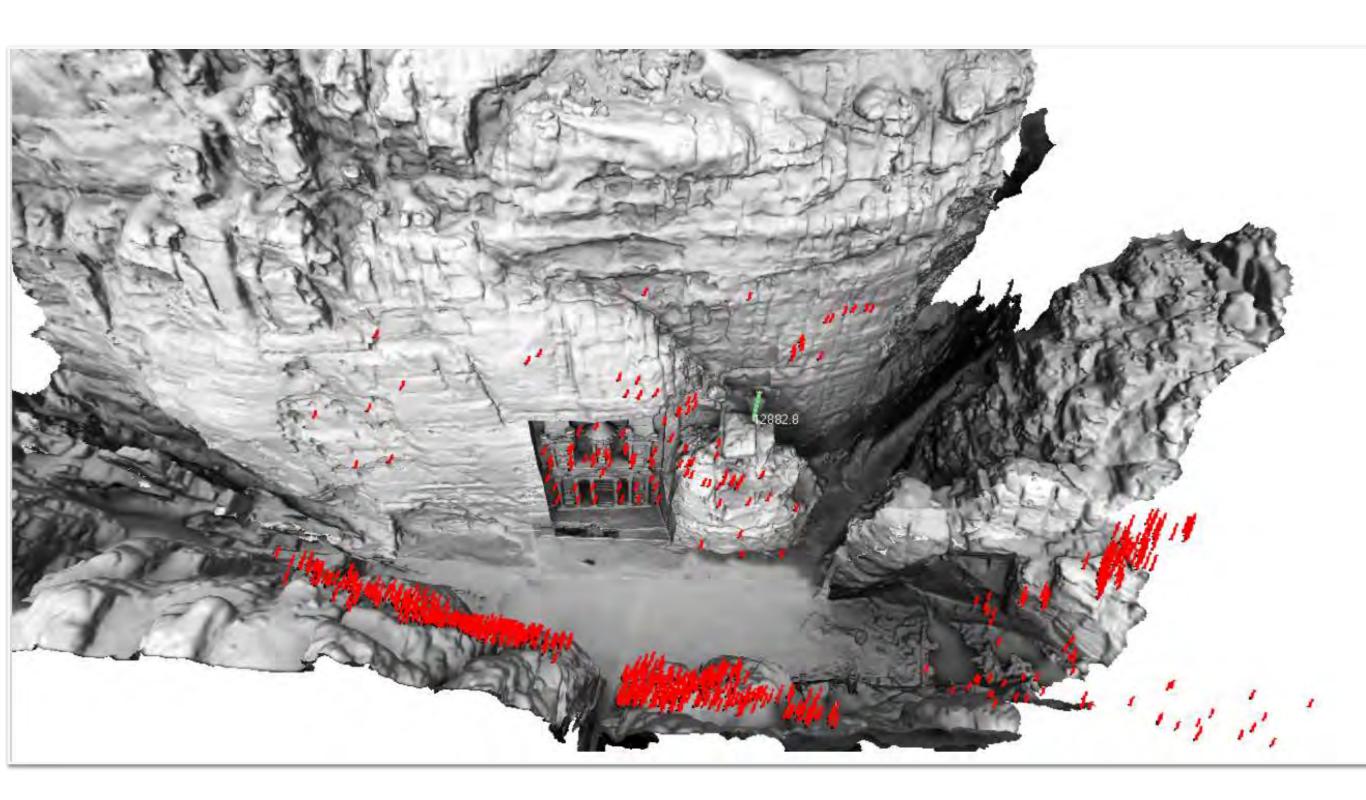
Petra (Jordan)

Robotized reflector-less total station

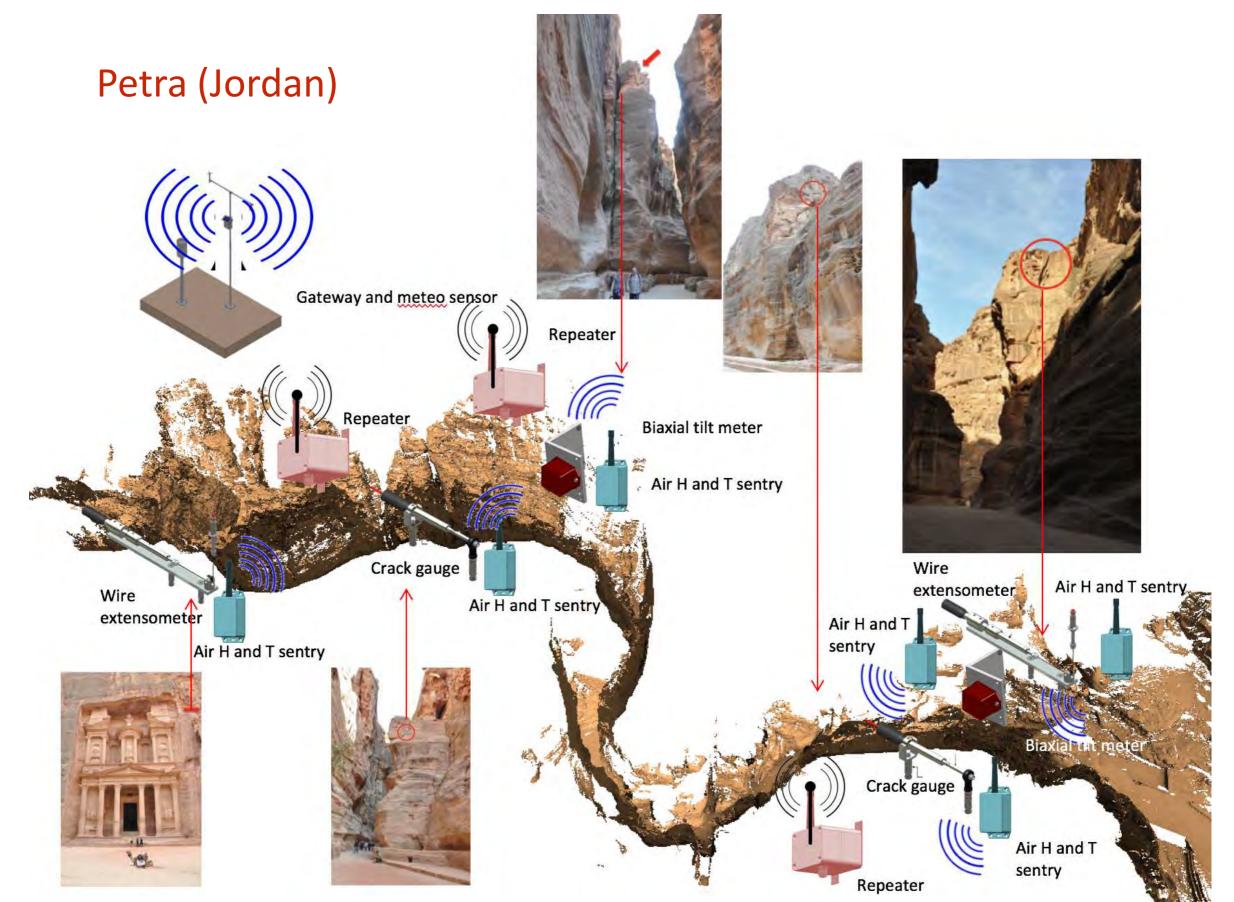
Wireless sensor networks

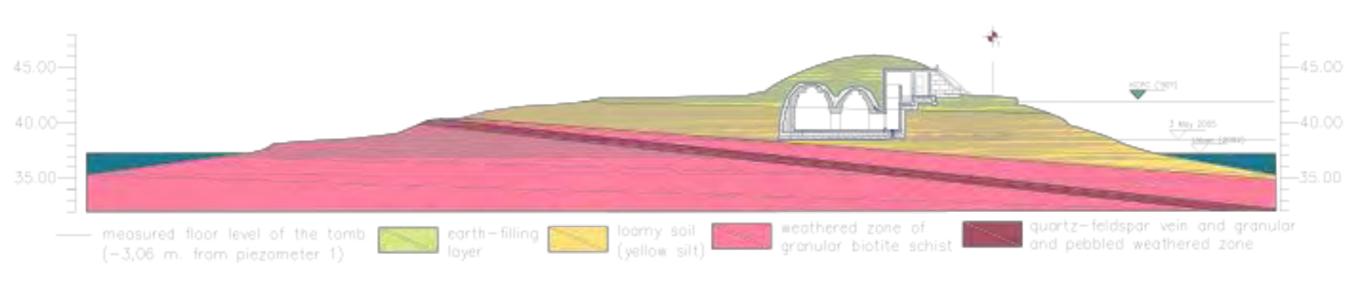
Kogurio (North Korea): Susan-ri mounded stone chamber tomb

Cross section through the tomb and the mound and the Yaksu-ry peninsula. The geological strata are reported as well as the measured levels of 3rd May 2005 regarding the water table, the floor of the tomb and the lake. It is reported the level of the lake in October 2002 (Urban 2002), on the 3rd May 2005 and in '90 as reported from a KCPC topographic section.

For a better comprehension also the sketch of the tomb is reported, at the same level of the measured floor but exhibiting a total length of 30 cm less than the one mentioned in the official documents.

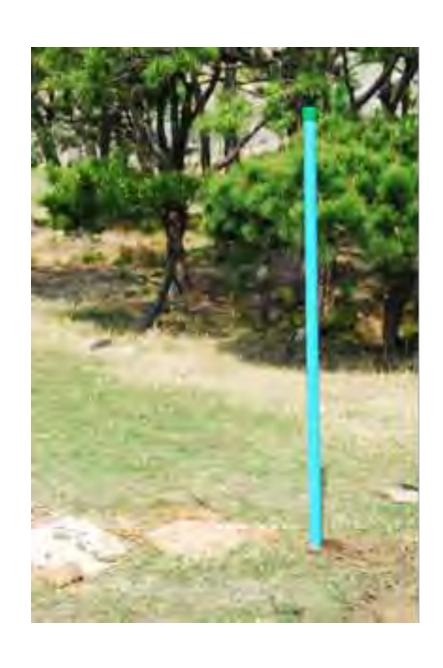
Kogurio (North Korea): piezometer drilling

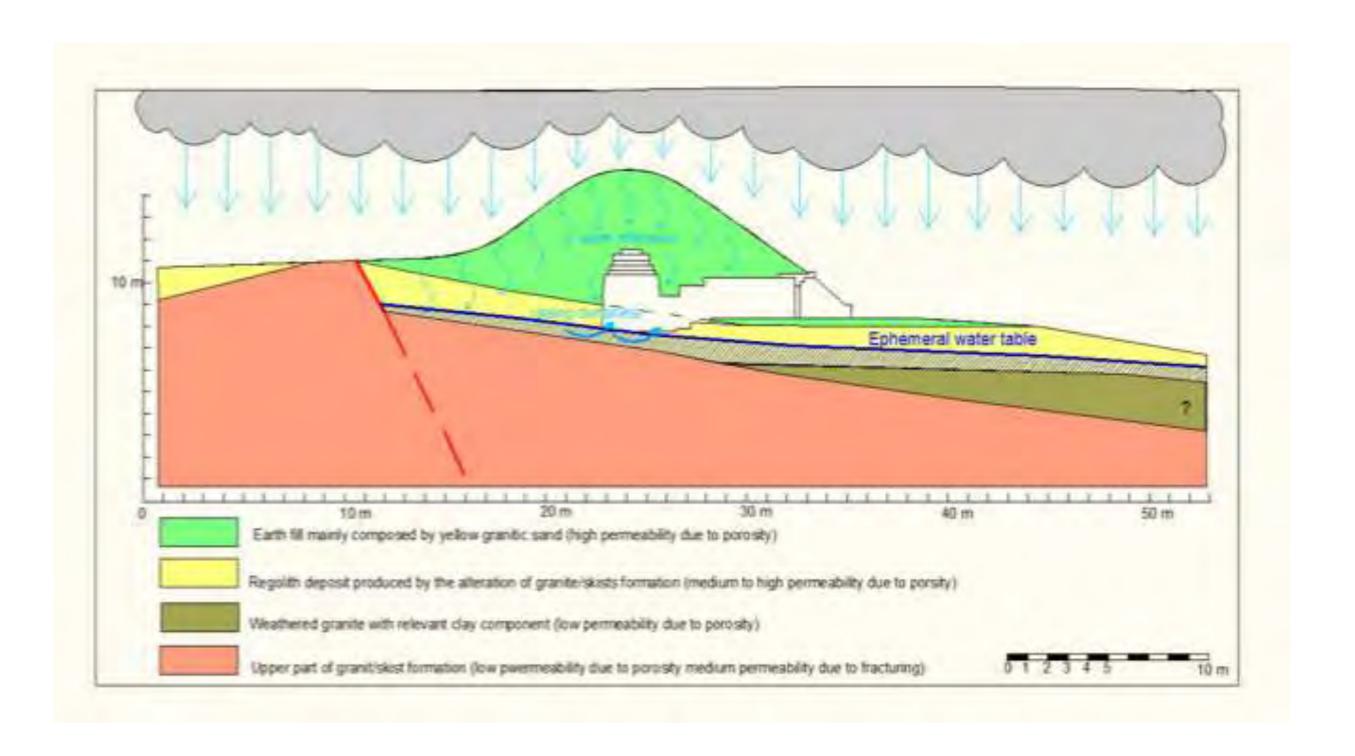
Kogurio (North Korea): piezometer deployment

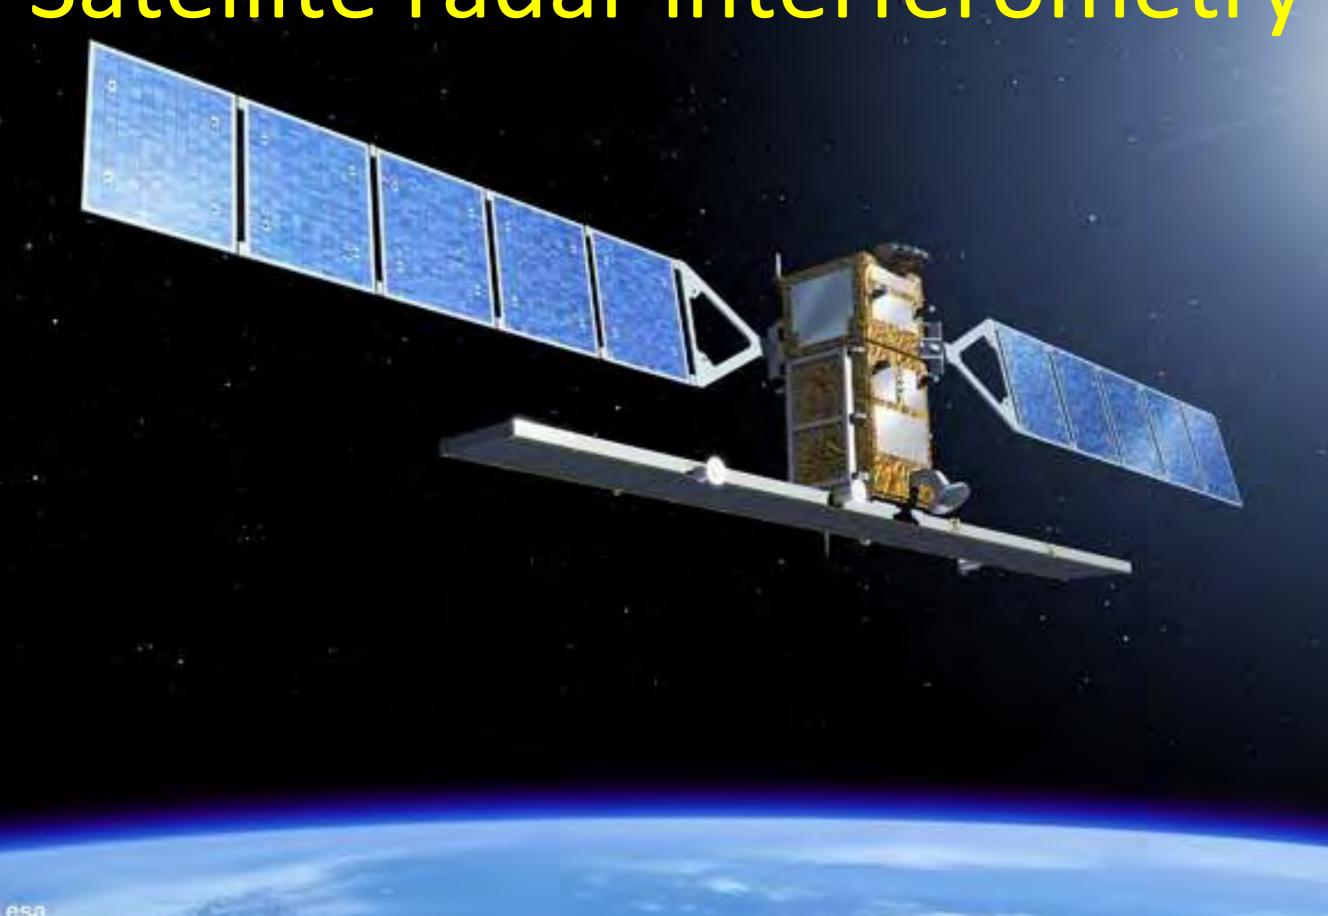
Satellite radar interferometry
